A Systematic Approach of Rock Slope Stability Assessment: A Case Study at Gunung Kandu, Gopeng, Perak, Malaysia

The stability of the limestone cliff at Gunung Kandu, Gopeng, Perak, Malaysia was assessed based on the Slope Mass Rating (SMR) system on 53 cross sections of the Gunung Kandu hill slopes. The slopes of Gunung Kandu were identified as class I (very good) to IV (poor). The kinematic analysis showed that 12 out of 53 hill slopes of Gunung Kandu were identified as having potential wedge, planar and toppling failures. The assessment showed that the stability of the western flanks can be classified as stable to unstable with the probability of failure from 0.2 to 0.6. The stability of the eastern and southern flanks range from very stable to partially stable with the probability of failure from 0.0 to 0.4. While the stability of northern flanks are from very stable to stable with the probability of failure of 0.0 - 0.2. This systematic approach offers a practical method especially for large area of rock slope stability assessment and the results from probability of failure values will help engineers to design adequate mitigation measures.

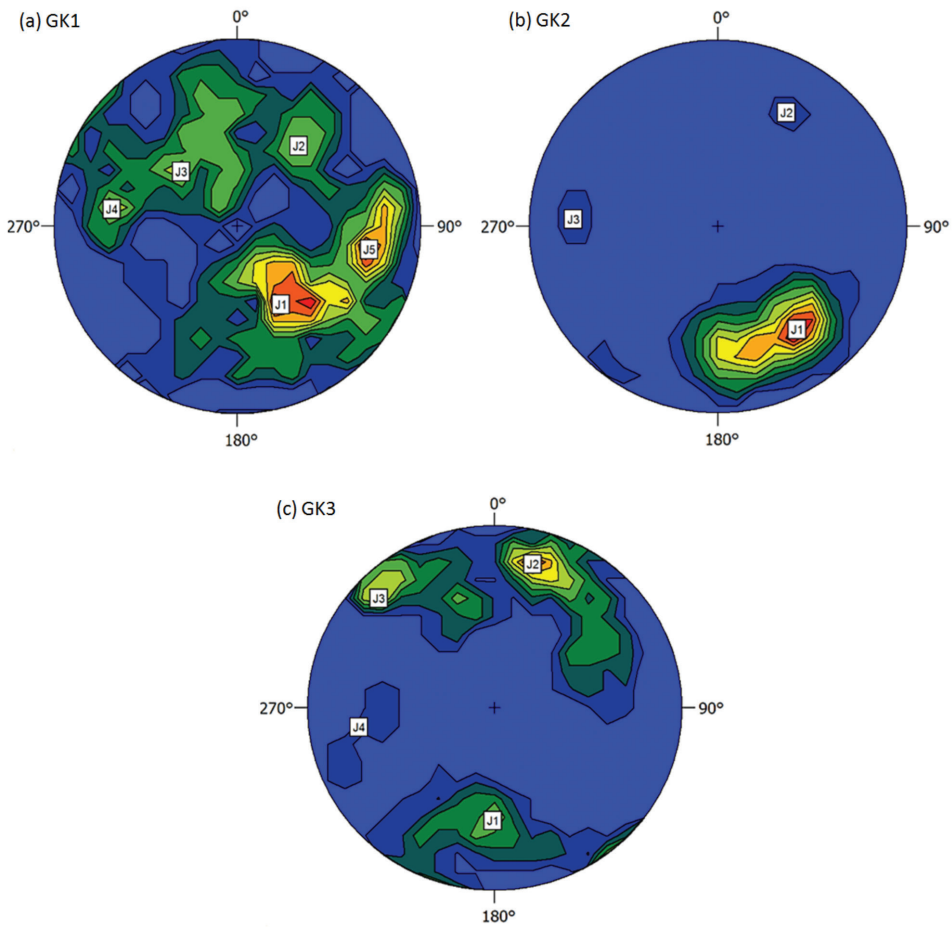
Slopes of GK1, GK2 and GK3 have 3 to 5 major joint sets. The orientation of the major joint sets and slope faces of respective slopes are presented in Table 1. The respective dip direction and dip angle of J1, J2, J3, J4 and J5 for GK1 were 331°/38°, 217°/49°, 135°/35°, 99°/59° and 279°/60°. The respective orientations (dip direction/dip angle) of J1, J2 and J3 for GK2 were identified as 322°/59°, 211°/60° and 91°/65°. The dip direction and dip angle of J1, J2, J3 and J4 for GK3 were 360°/51°, 194°/70°, 135°/75° and 80°/64°.

FIGURE 3. Stereographic plot of slope of (a) GK1, (b) GK2 and (c) GK3, Gunung Kandu, Gopeng, Perak

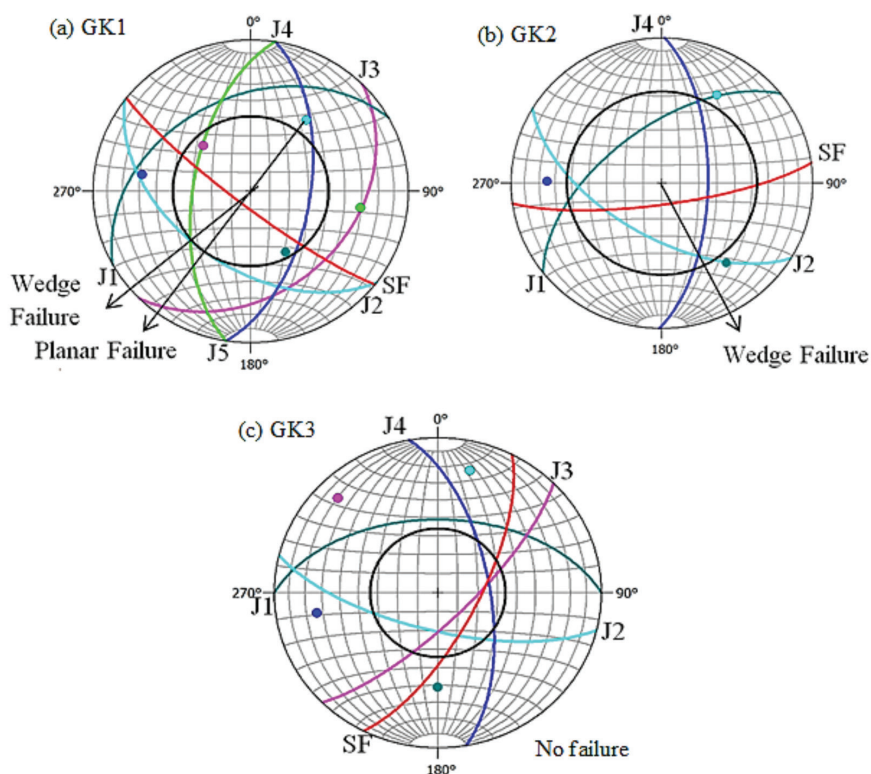
The peak friction angles of the geological discontinuities for respective slopes for kinematic analysis were determined based on the tilt testing method, suggested by Abdul Ghani and Goh (2012). The peak friction angle of 49°, 37° and 55° were used in the kinematic analysis for the respective slopes GK1, GK2 and GK3. Figure 4 shows the results of kinematic analysis for the respective slopes. The modes of failure for slope GK1 were wedge and planar failure with the dip direction and dip angle of 231°/49° and 217°/49°, respectively. A wedge failure was identified on slope GK2 with the dip direction and dip angle of 154°/44°. No failure was identified for slope GK3. The results of kinematic analysis were utilized in rock mass classification assessment based on SMR method.

FIGURE 4. (a) For slope GK1, a planar and a wedge failure were identified with the dip direction and dip angle of $231^{\circ}/49^{\circ}$ and $217^{\circ}/49^{\circ}$, respectively, (b) For slope GK2, a wedge failure was identified on slope GK2 with the dip direction and dip angle of $154^{\circ}/44^{\circ}$ and (c) For slope GK3, no failure was identified

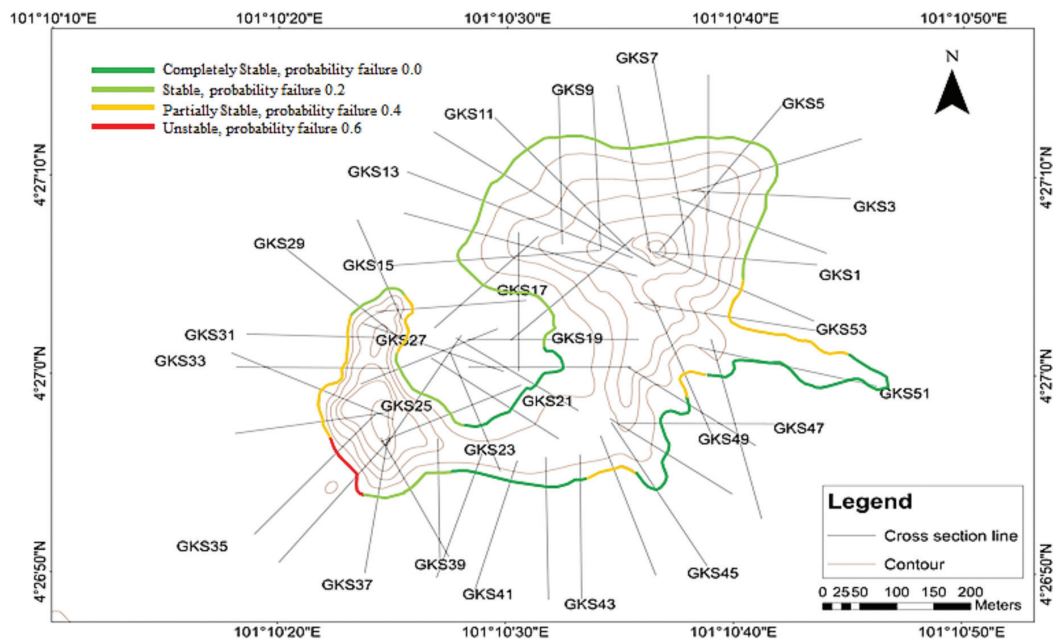
to GKS28, GKS31 to GKS37, GKS40, GKS44 and GKS49. The assessment showed that the stability of Gunung Kandu ranges from completely stable to unstable with the probability of failure from 0.0 to 0.6. The rating for the western flank range from stable to unstable with the probability of failure from 0.2 to 0.6. The stability of

the eastern and southern flank range from very stable to partially stable with the probability of failure of 0.0 to 0.4 and the stability of the northern flank is classified as very stable to stable with the probability of failure from 0.0 to 0.2. The results also showed that the western flank of hill was less stable than eastern, southern and northern flanks of hill.

The assessment results showed most of the slopes are classified as very stable to partially stable from class I to III except for slope GKS35 and GKS36. Slopes GKS35 and GKS 36 of western flank are classified as unstable

and class IV slopes because the dip direction (217°) of potential planar failure are almost parallel with the dip directions of slope face of GKS35(221°) and GKS36 (217°) with the differences of 2° to 4° . Therefore, both slopes were rated as very unfavourable in F1, SMR. In addition, both slopes anticipated very unfavourable 'daylighting' condition which contributed to high score of F3 in SMR. It is suggested that discontinuum approach using numerical or limit equilibrium method is conducted to determine the factor of safety for both slopes and proposed appropriate mitigation measures.

FIGURE 5. Map of slope stability assessment of Gunung Kandu, Gopeng, Perak, Malaysia

The relevant agencies such as Federal Department of Town and Country Planning and city council could use the results of this study in their development planning. The area under unstable slope should be restricted for future development unless the unstable slope is engineered with comprehensive mitigation measures.
